TYNDALL AFB PRE-DEMOLITION SURVEY

Pre-Demolition Report for
Asbestos, Hazardous Materials & Soil Testing

For:
Facilities Reduction Program FY19 Tyndall II
Tyndall AFB, Florida
Building 107 F-22 AME Storage

March 2020

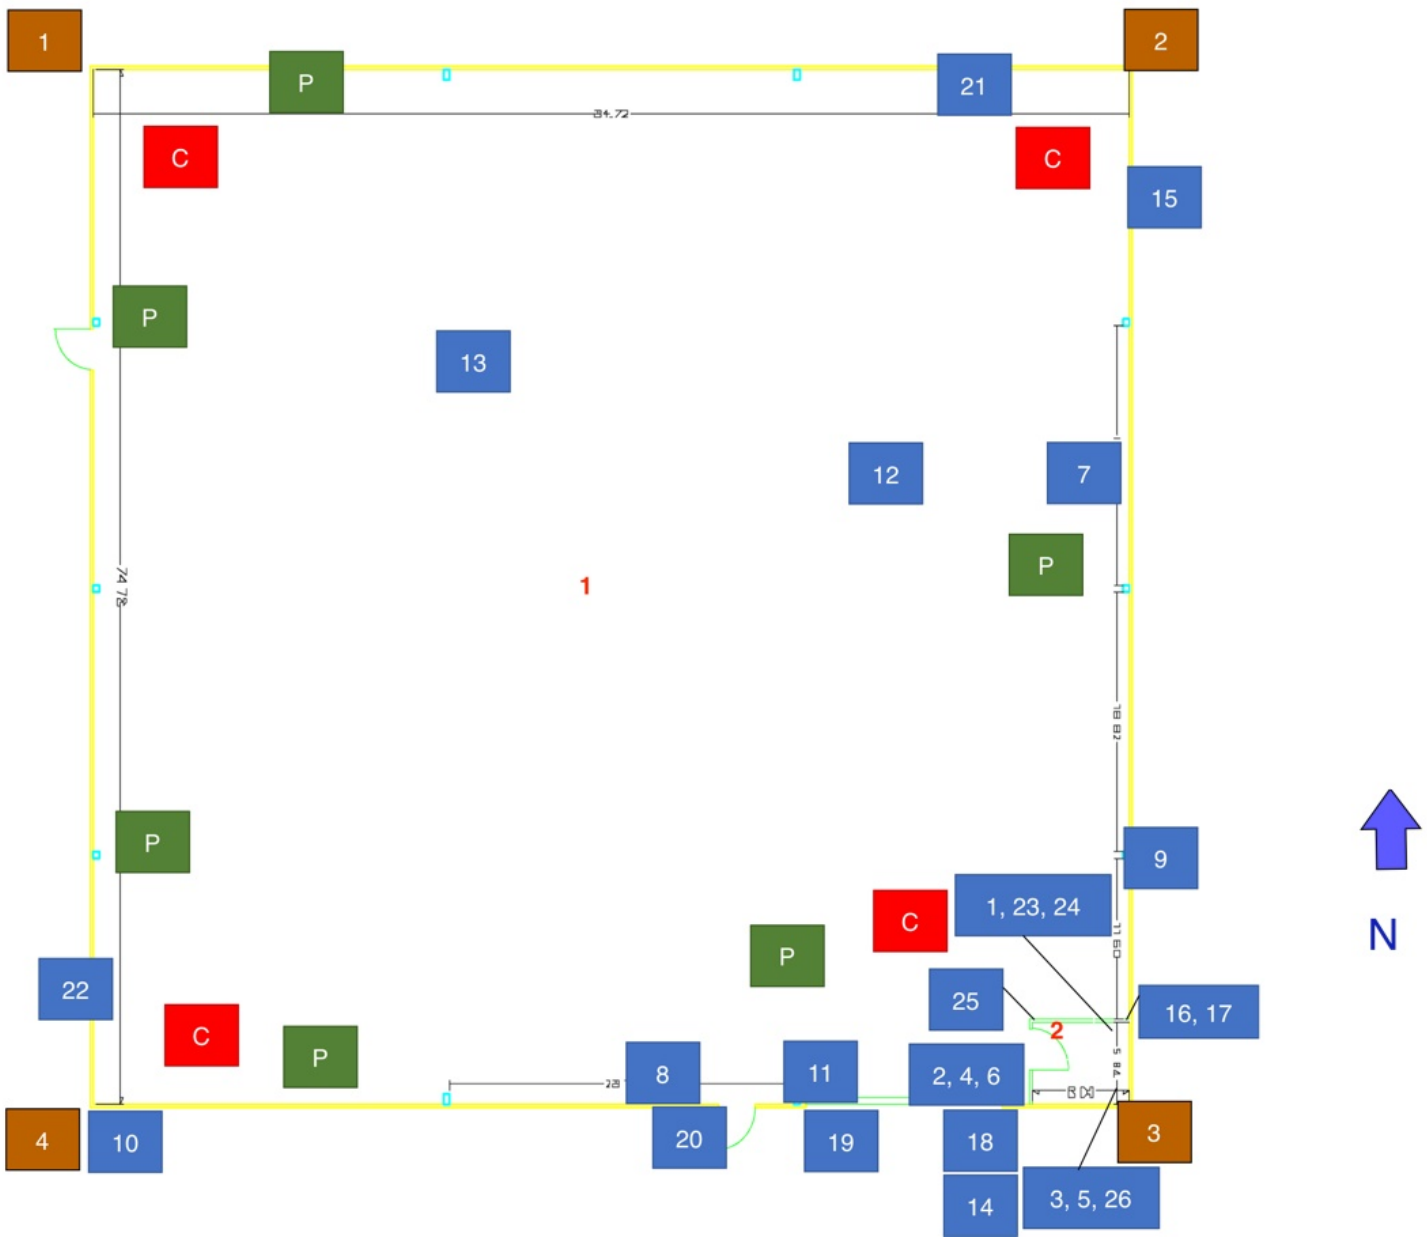
Sampling Locations

The soil analytical results identified the compound 4,4'-DDT at a concentration of 25 mg/kg in the 0 to 6-inch interval of borehole number 4 (sample OCP-107.7) and in the duplicate sample at a concentration of 14 mg/kg (sample OCP-107.9). The reported concentrations in OCP-107.7 are above the Commercial/Industrial and Residential SCTLs of 15 mg/kg and 2.9 mg/kg, respectively. 4,4'-DDT concentrations in duplicate sample OCP-107.9 are just below the Commercial/Industrial SCTL, but above the Residential SCTL

Upon completion of building demolition and concrete pad removal, AirQuest recommends that the area of impacted soil (southwest corner of building) be excavated and stockpiled onsite. The excavation should extend to a depth of two (2) feet below land surface (BLS) and extend out in an approximate three (3) foot radius around borehole number 4. Five (5) confirmation samples should be collected from the excavation area and submitted for laboratory analysis to confirm 4,4'-DDT is below the residential FDEP SCTL.

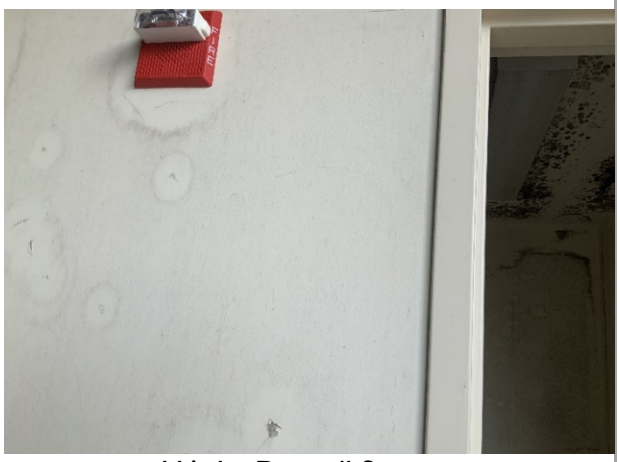
HA 1 - Drywall System	 HA 2 - 4" Gray Vinyl Base Cove
 HA 3 - Concrete Block Wall	 HA 4 - Concrete Slab Floor
 HA 5 - Gray Putty	 HA 6 - Brown Expansion Material

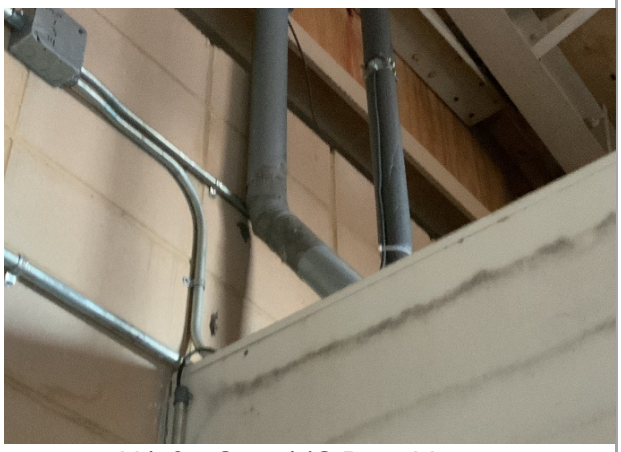
HA Photolog Bld 107 - F-22 AME STORAGE Tyndall Air Force Base	AirQuest Environmental, Inc. Project #15671 March 2020
 HA 7 - White Mastic at Exterior Metal Pipe

HA 8 - Gray A/C Duct Mastic
 HA 9 - 12” x 12” Gray Vinyl Floor Tile
